October 6, 2005

M. E. Simpson Company is pleased to submit this report of our leak detection survey for the City of Brazil. This survey addressed the Brazil water distribution system, consisting of approximately 73 miles of water main. The report contains the results of our investigation that includes the following:

## LEAK LOCATION REPORT

**Client:** Brazil, Indiana

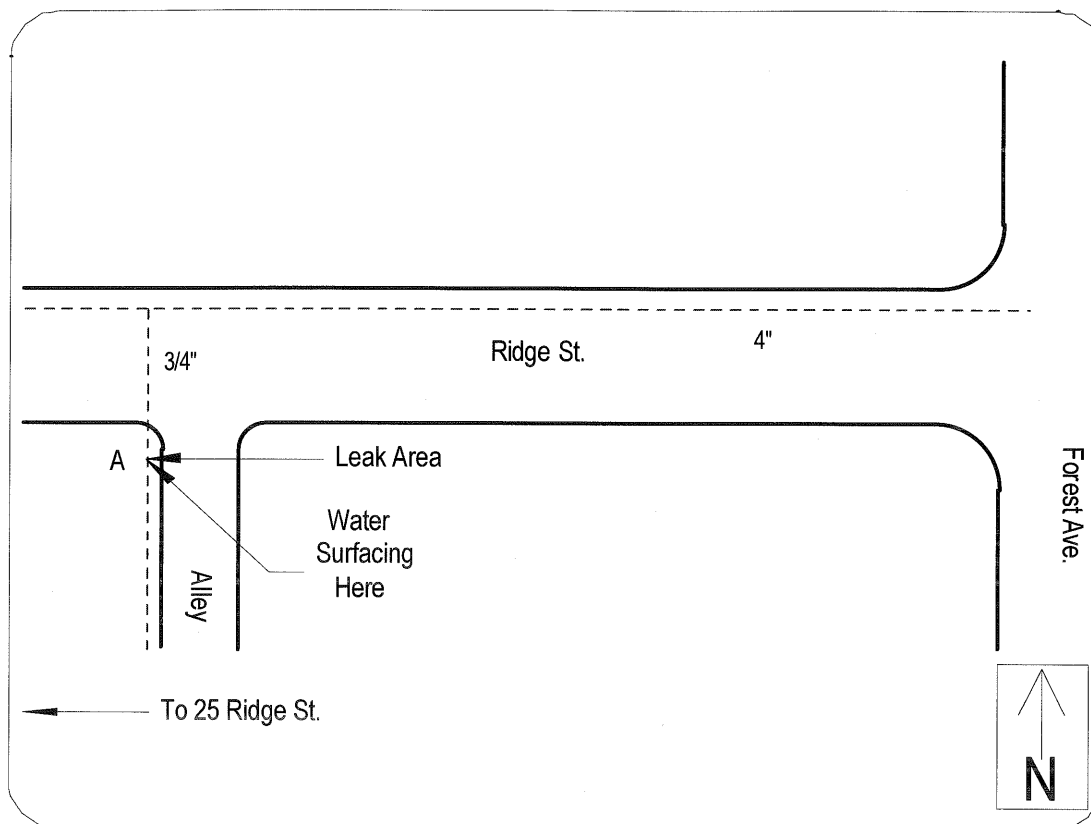
**Address:** 25 Ridge Street

**Leak Location:** 0' from A

**Comments:** This is a leak on a 3/4" main. We notified the Utility and they were to repair this leak immediately.

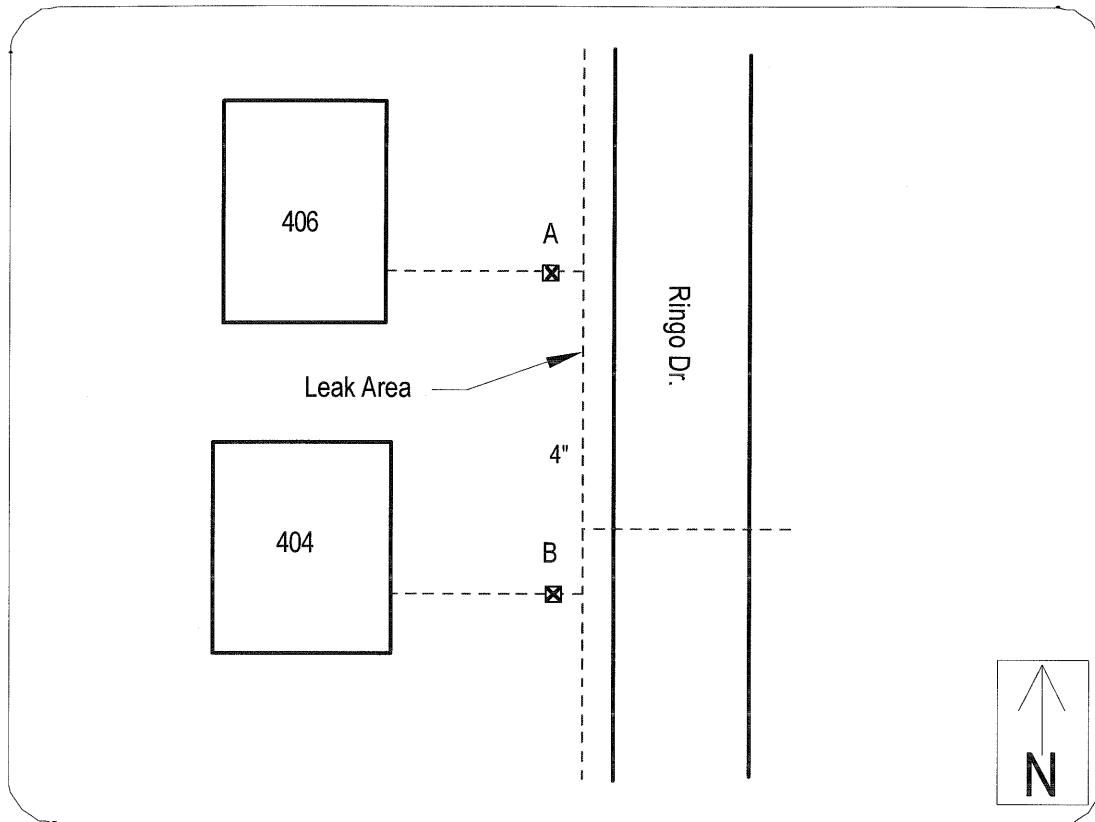
**Address:** 406 Ringo Drive

**Leak Location:** 22' from A

**Comments:** This is a leak on a 4" main. The Utility was notified and will repair this leak.

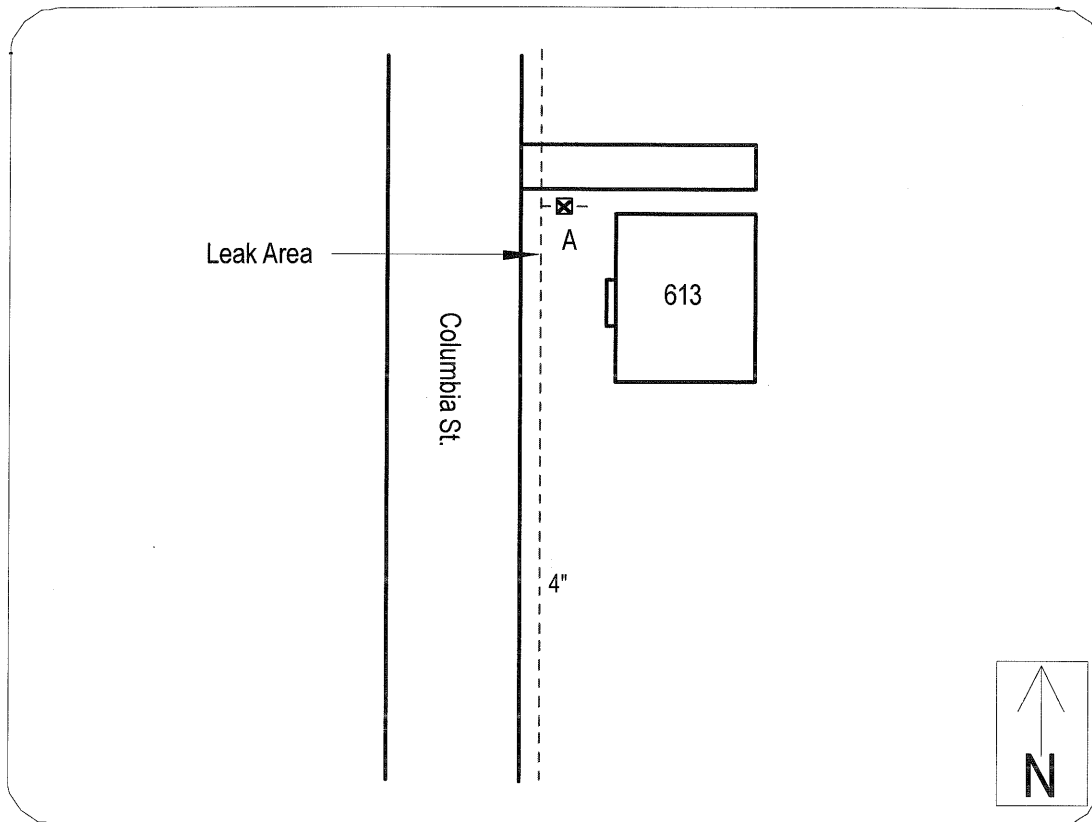
**Address:** 613 Columbia Street

**Leak Location:** 15' from A

**Comments:** This is a leak on a 4" main.

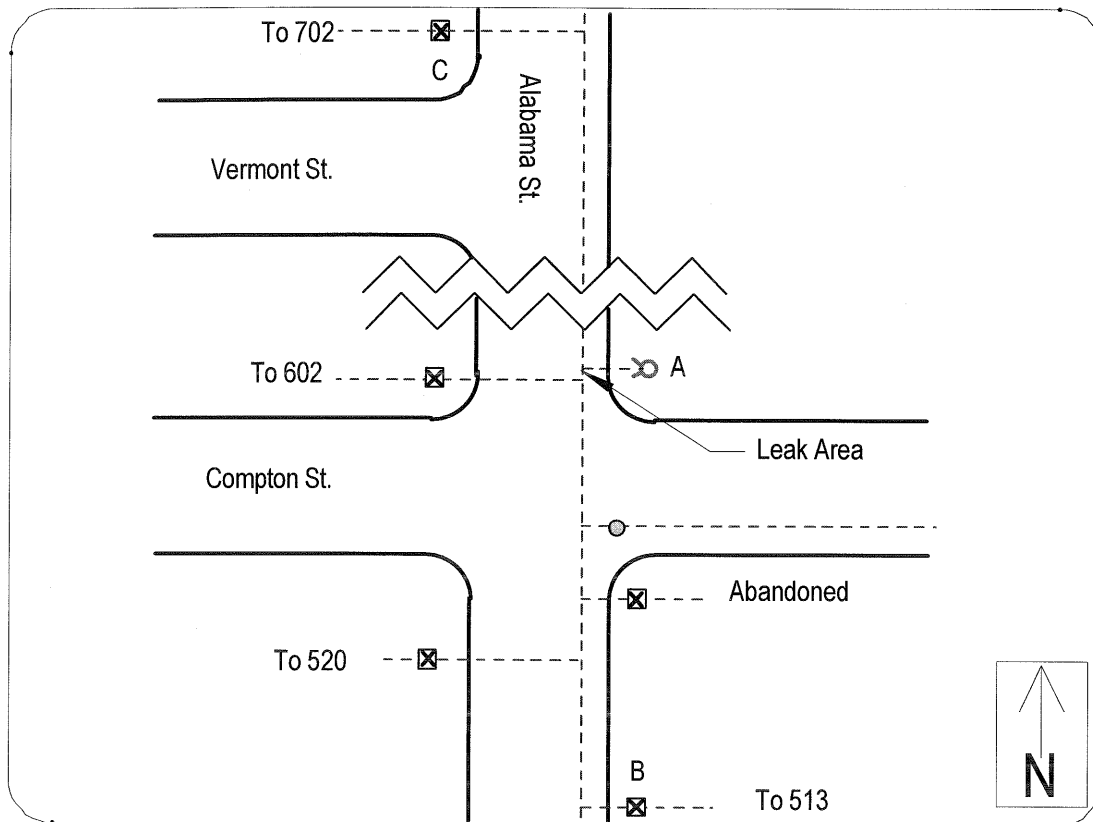
**Address:** Alabama Street & Compton Street

**Leak Location:** 13' from A

**Comments:** This is a leak on the main where it connects to the hydrant lead.

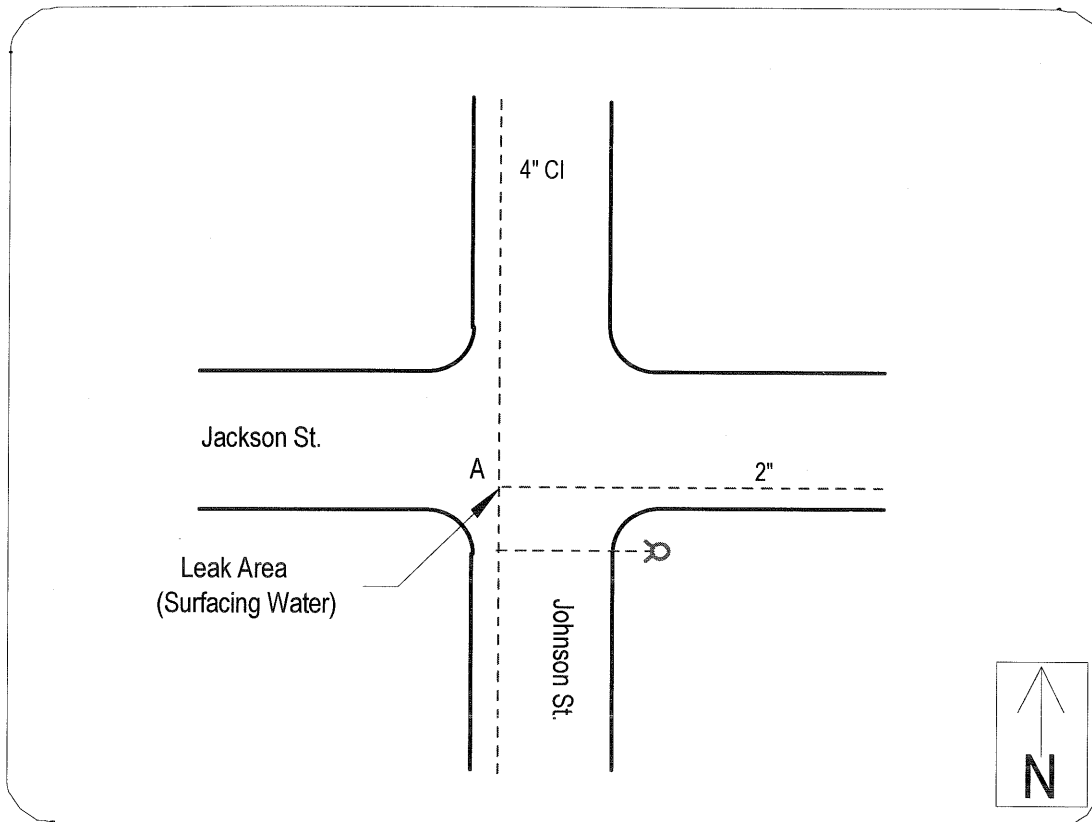
**Address:** Johnson Street & Jackson Street

**Leak Location:** 0' from A

**Comments:** This is a main line leak. The Utility was notified and will repair this leak.

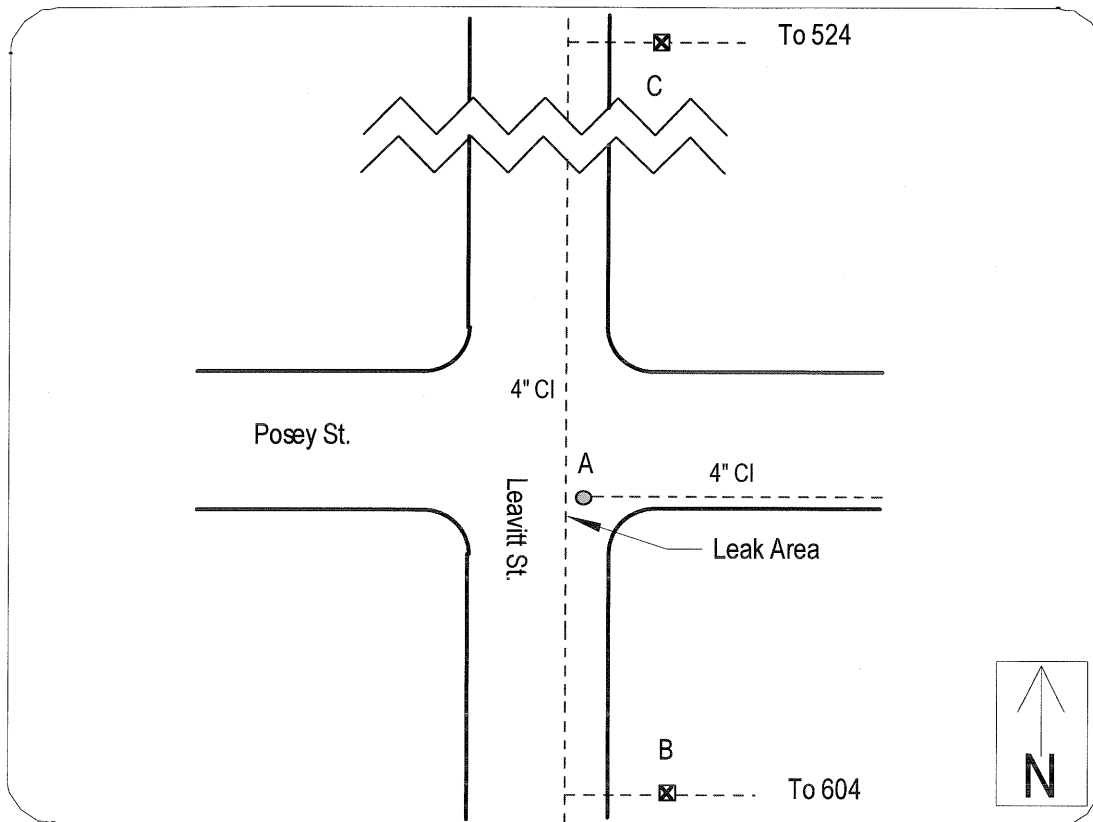
**Address:** Leavitt Street & Posey Street

**Leak Location:** 3' from A

**Comments:** This is a leak on a 4" main.

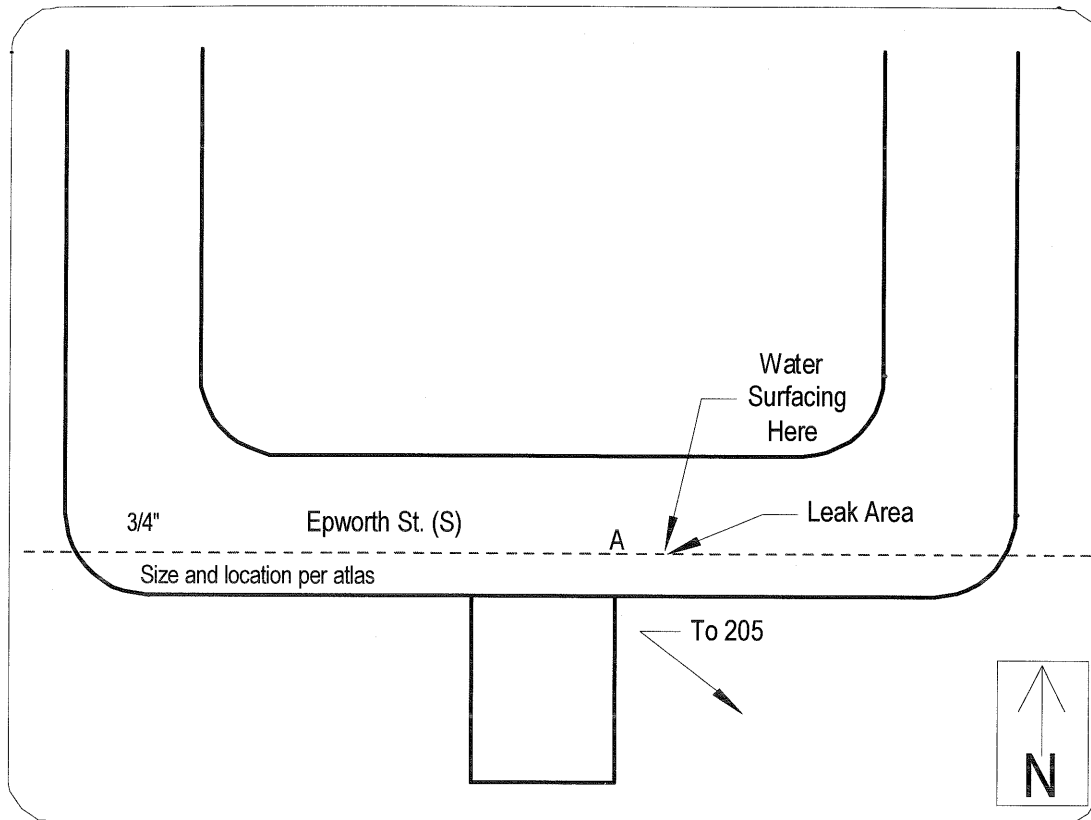
**Address:** 205 Epworth Street (S)

**Leak Location:** 0' from A

**Comments:** This is a leak on a 3/4" main. The Utility has been notified.

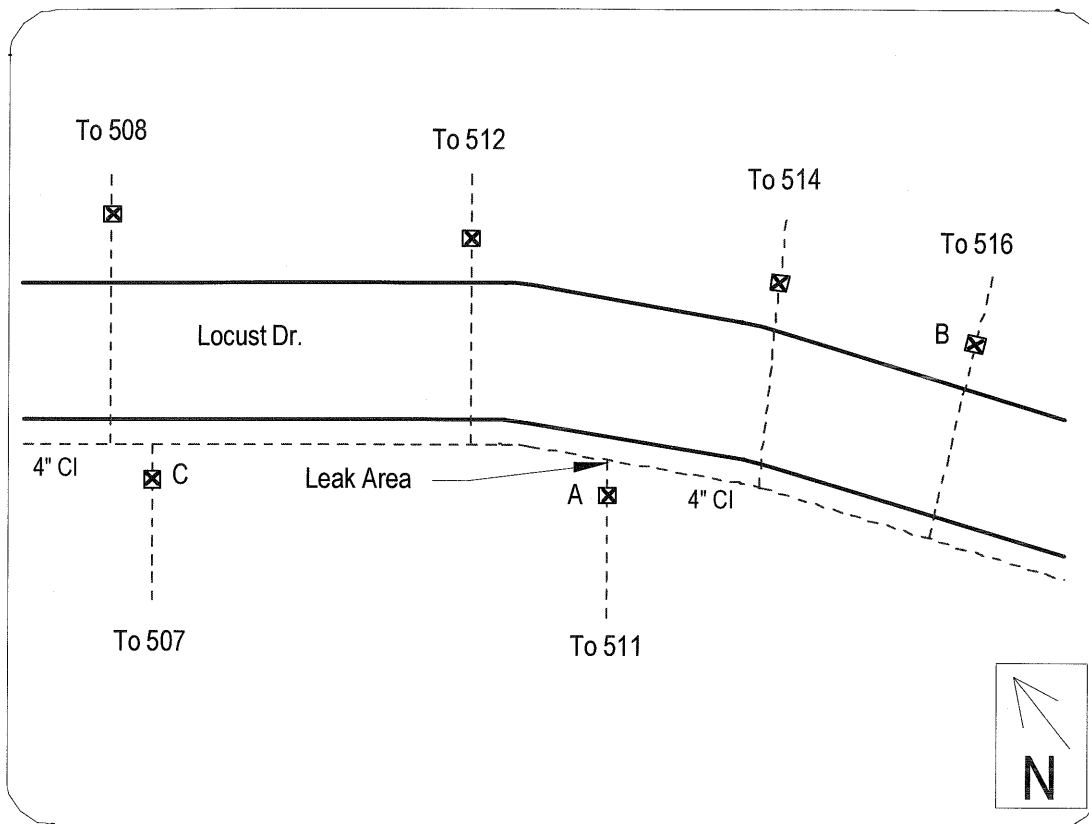
**Address:** 511 Locust Drive

**Leak Location:** 9' from A

**Comments:** This is a service leak.

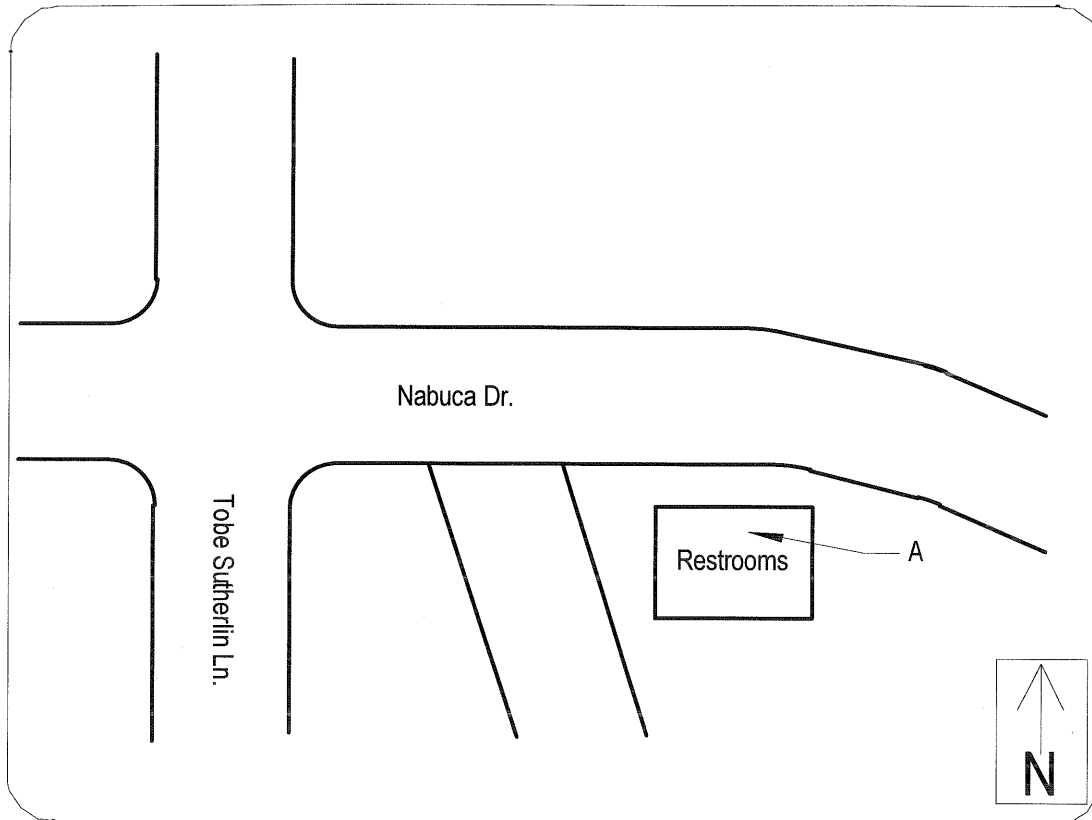
**Address:** Tobe Sutherlin Lane & Nabuca Drive

**Leak Location:** 0' from A

**Comments:** This is a leak on the Sloan valves on the urinals. The valves are on full flush at all times. This is unmetered water.

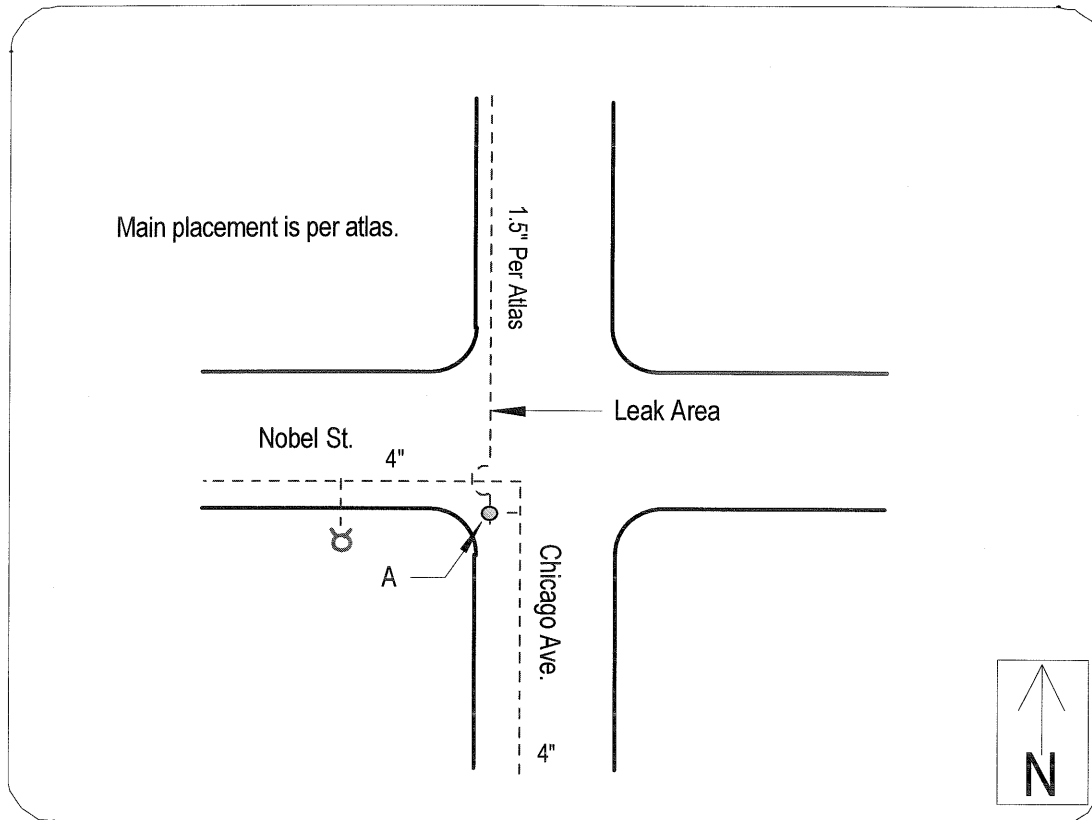
**Address:** Chicago Avenue & Noble Street

**Leak Location:** 17' from A

**Comments:** This is a valve leak. This leak is surfacing and the Utility has been notified.

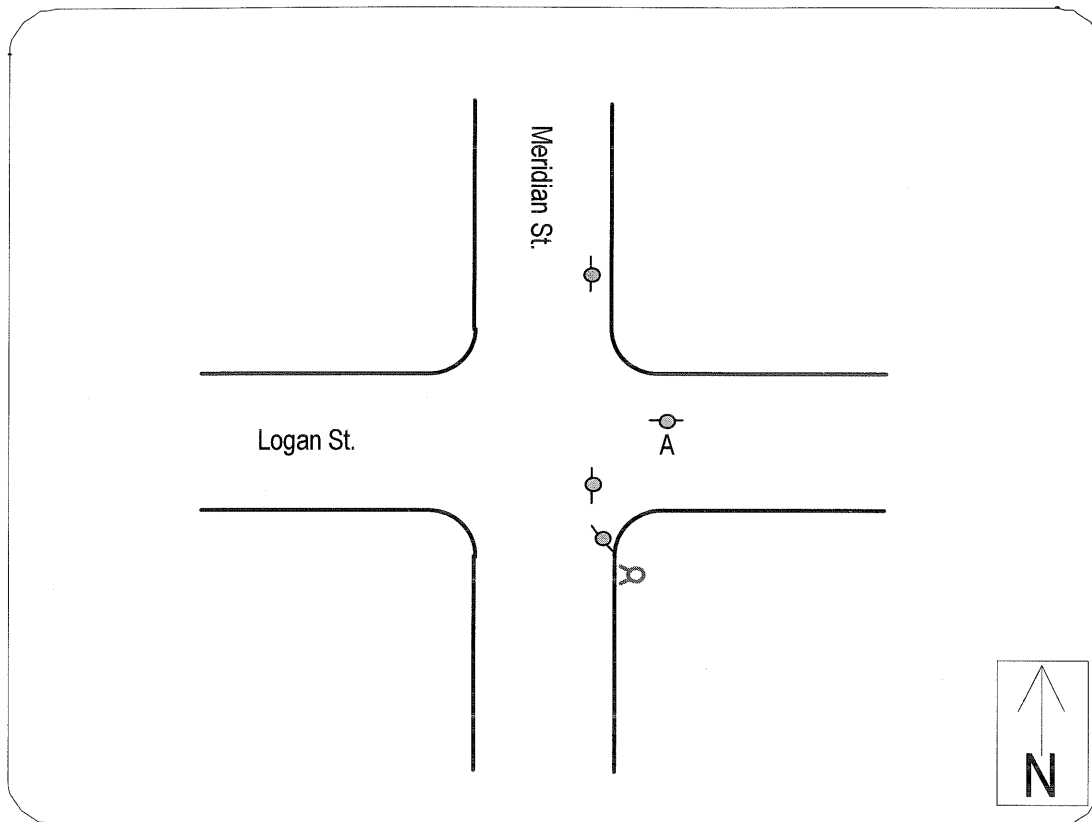
**Address:** Meridian Street & Logan Street

**Leak Location:** 0' from A

**Comments:** This is a packing leak on a main line valve.

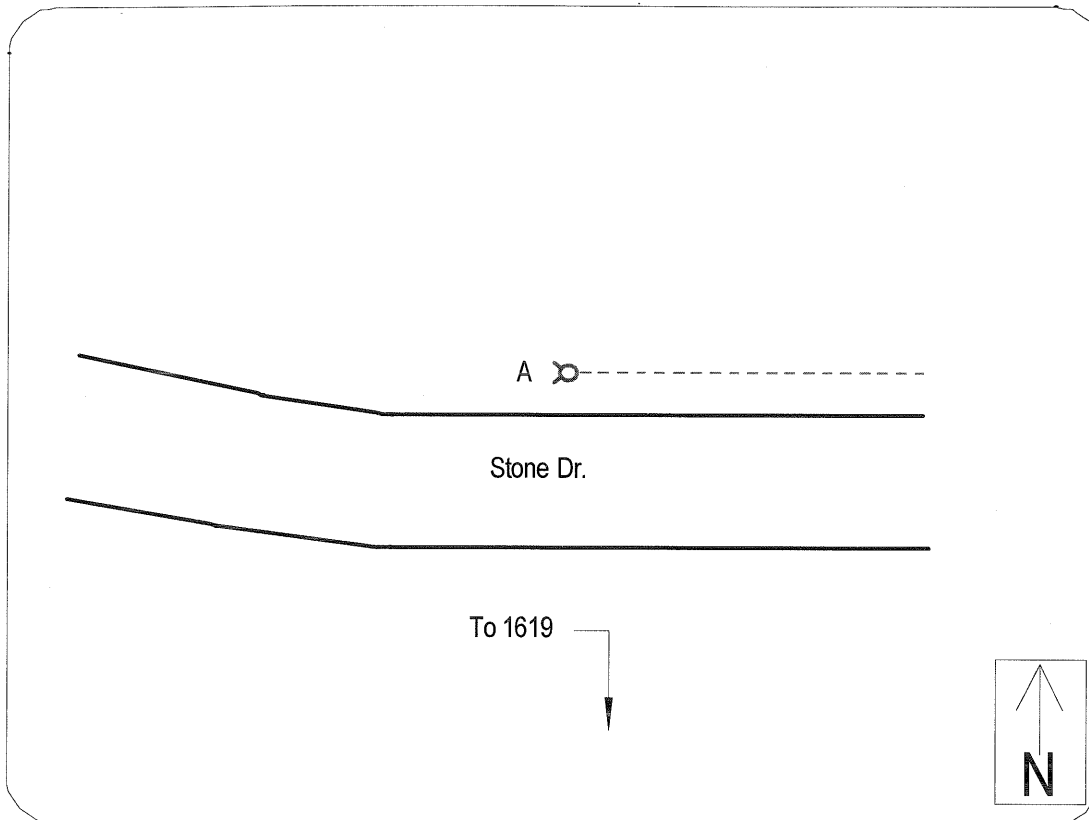
**Address:** 1619 - 1638 Stone Drive

**Leak Location:** 0' from A

**Comments:** This is a leak on the flush hydrant. It could not be shut off. The Utility removed the hydrant.

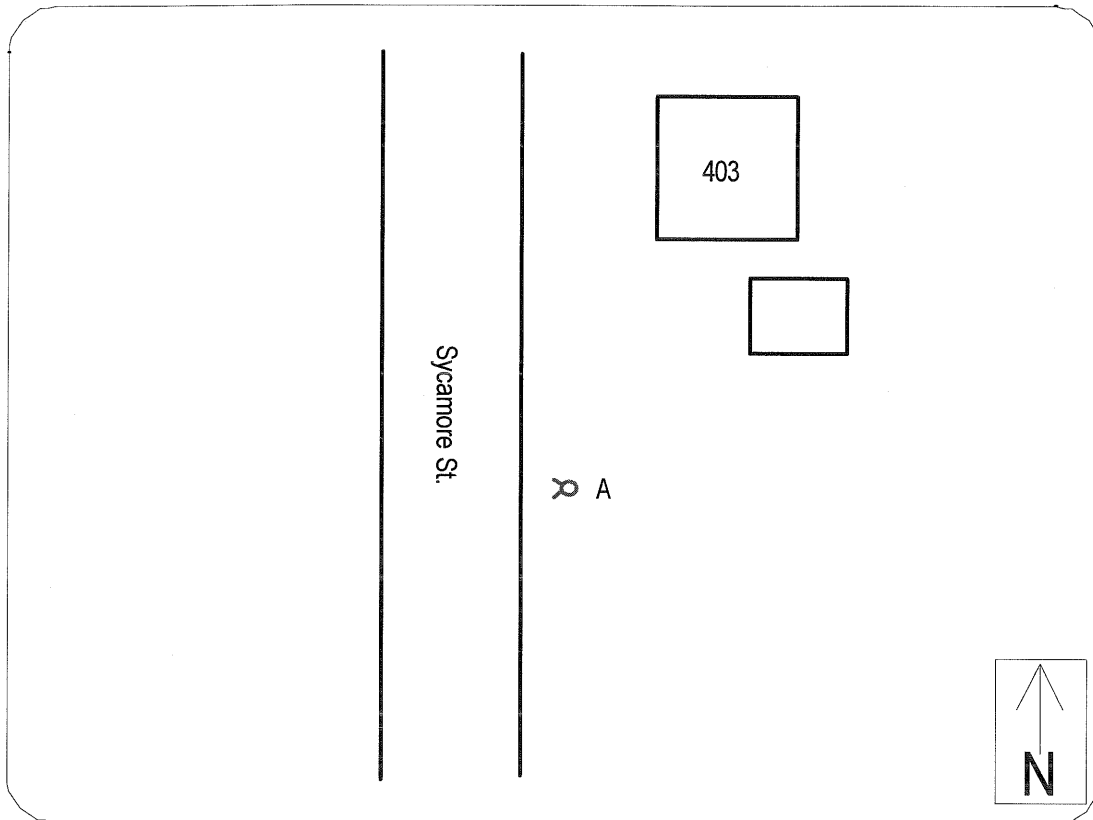
**Address:** 403 Sycamore Street

**Leak Location:** 0' from A

**Comments:** This is a hydrant leak.

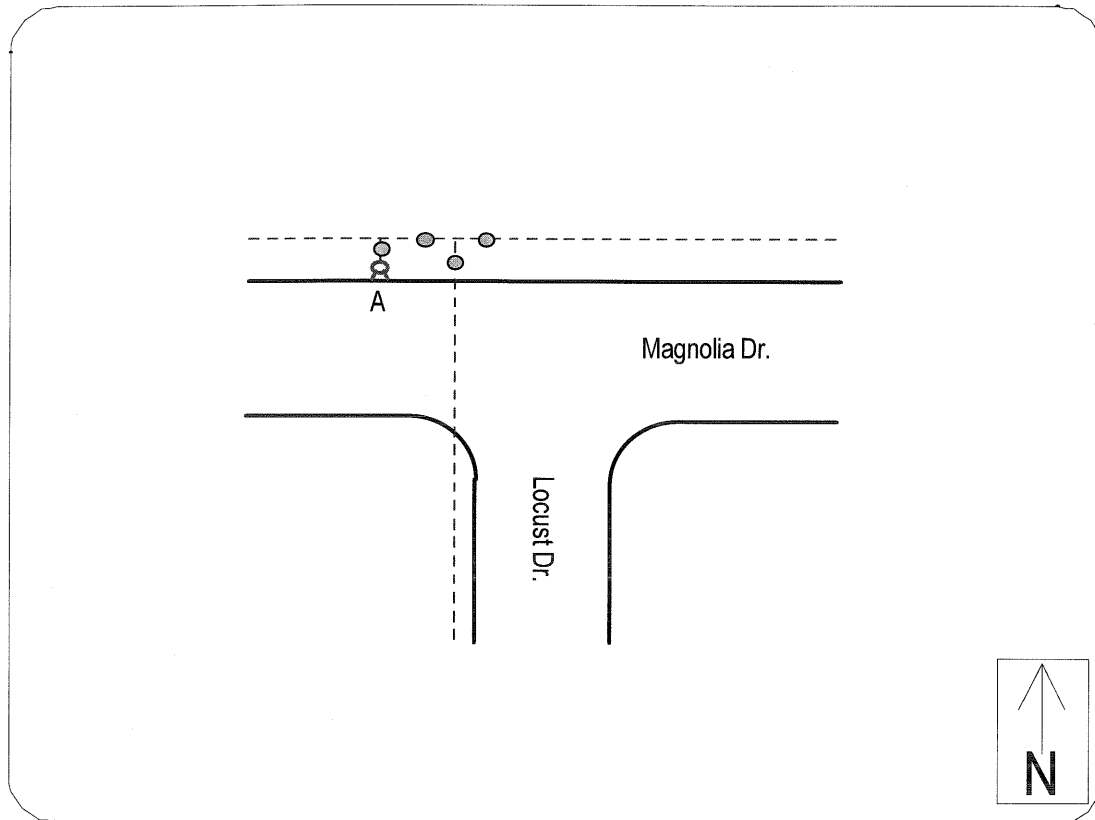
**Address:** Locust Drive & Magnolia Drive

**Leak Location:** 0' from A

**Comments:** This is a hydrant leak.

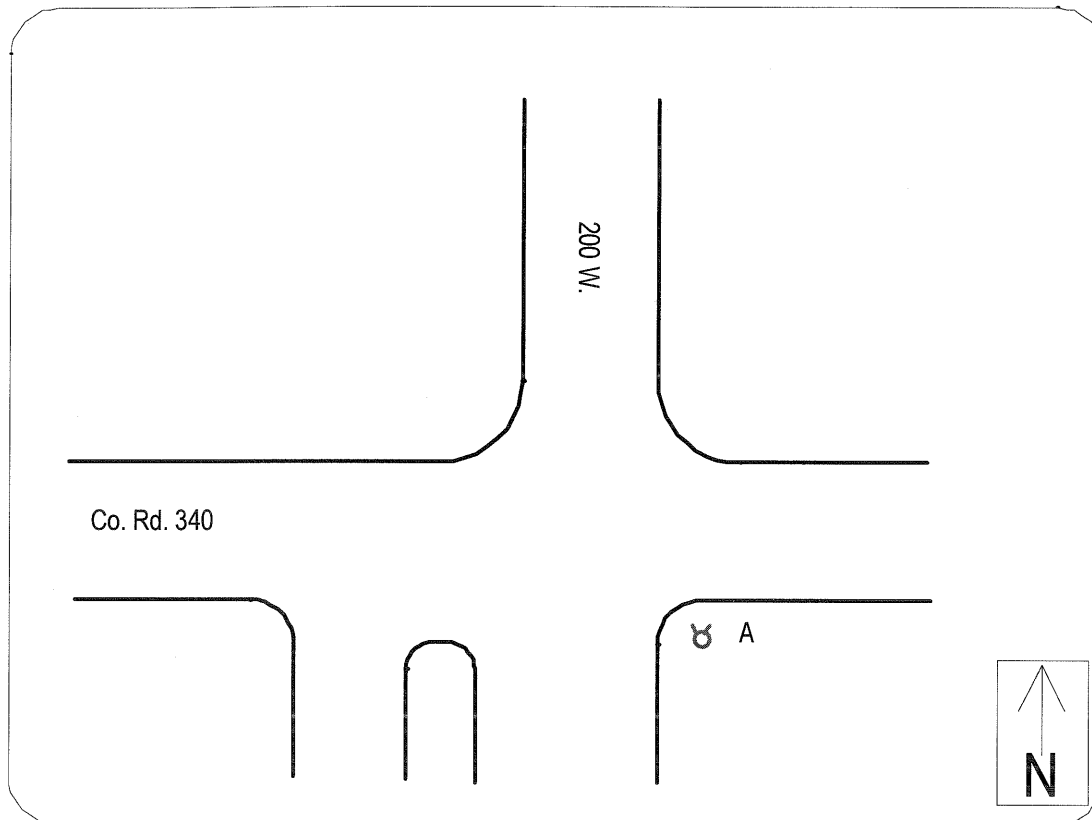
**Address:** 200 West & County Road 340

**Leak Location:** 0' from A

**Comments:** This is a hydrant leak. The rear body of hydrant was split to the bonnet.

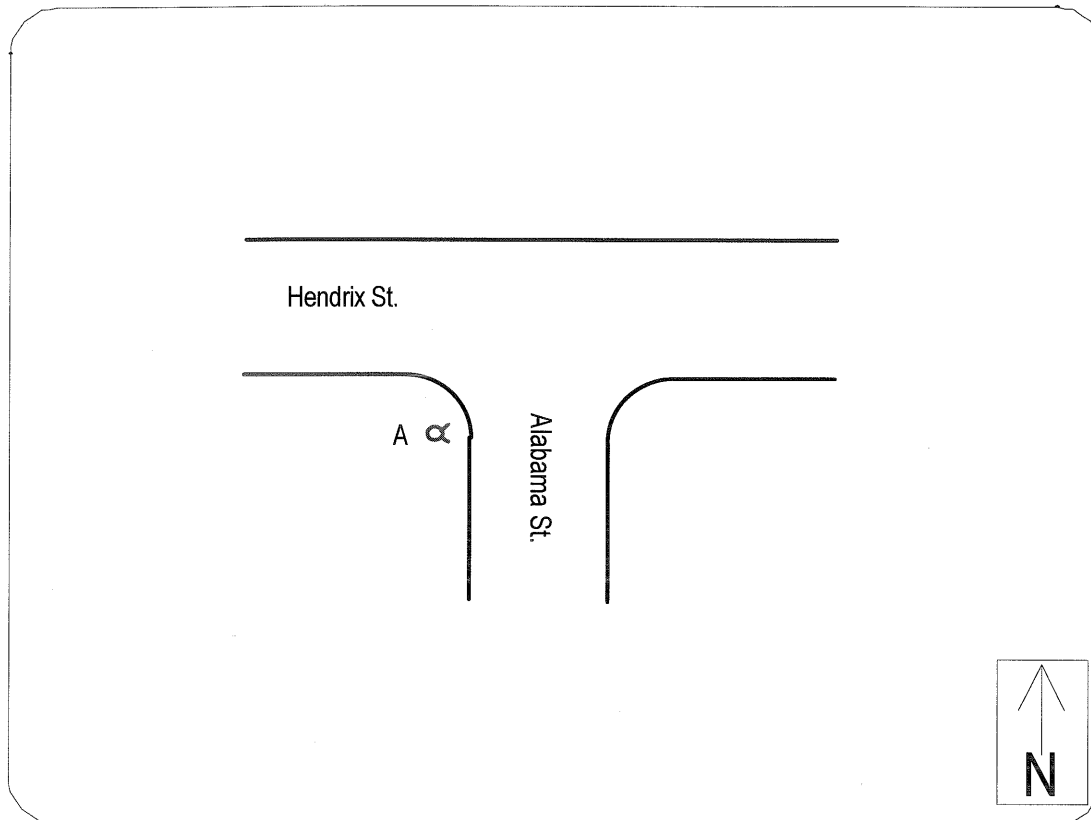
**Address:** Alabama Street & Hendrix Street

**Leak Location:** 0' from A

**Comments:** This is a hydrant leak.

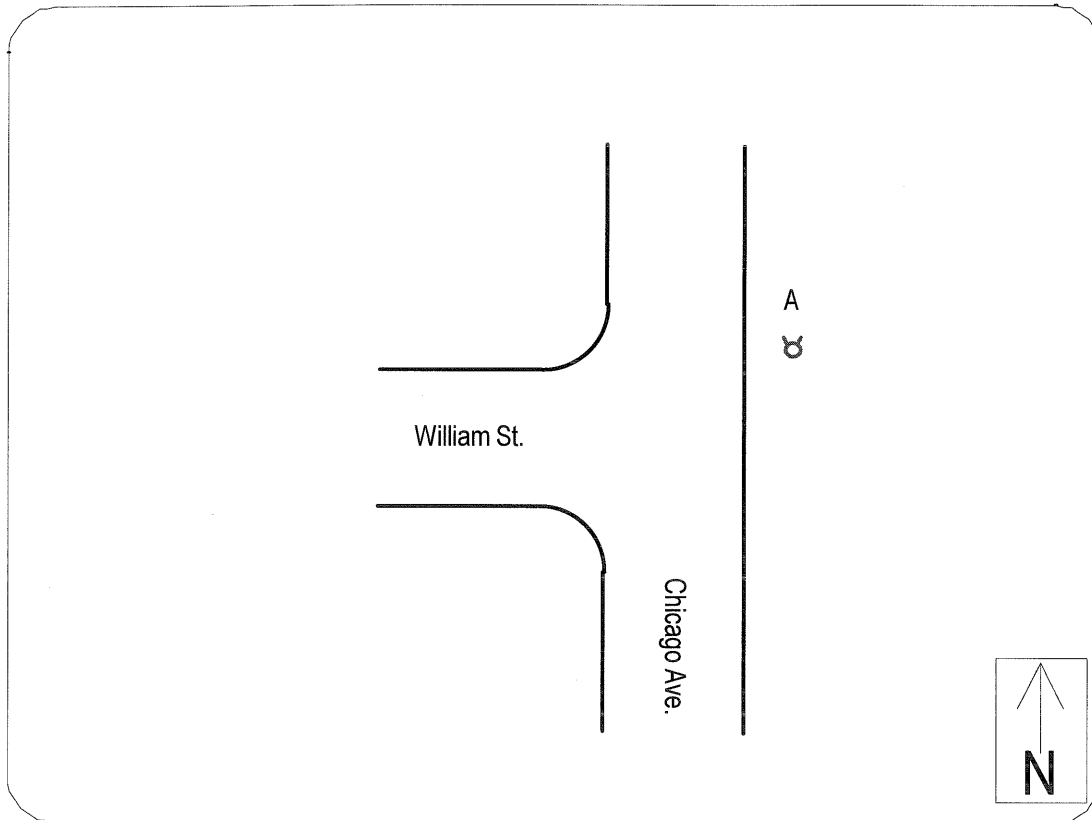
**Address:** Chicago Avenue & William Street

**Leak Location:** 0' from A

**Comments:** This is a hydrant leak.

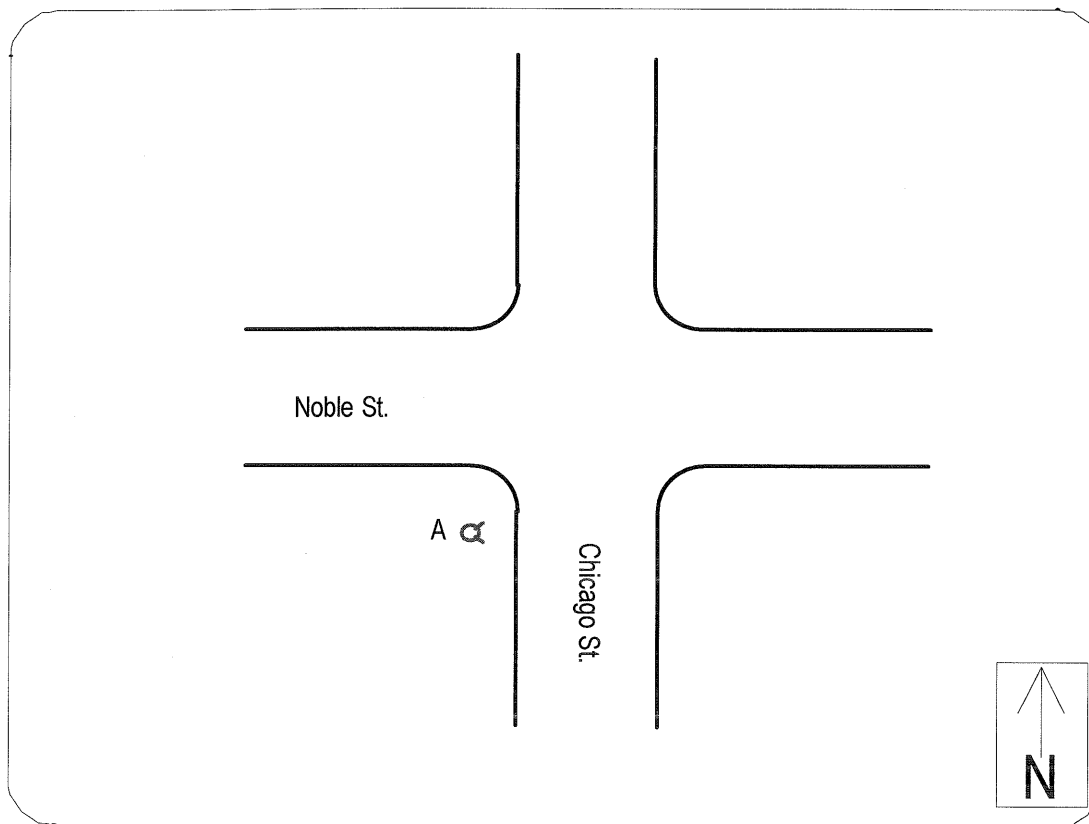
**Address:** Chicago Street & Noble Street

**Leak Location:** 0' from A

**Comments:** This is a hydrant leak.

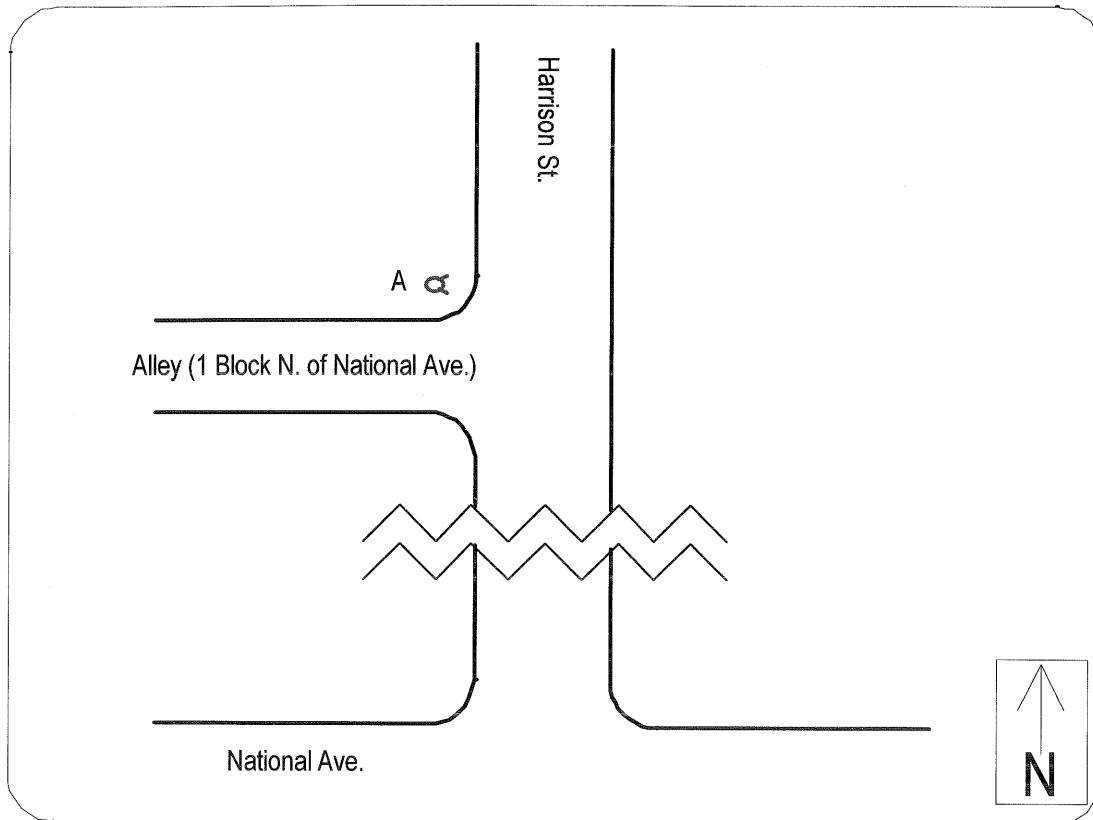
**Address:** Harrison Street & National Avenue

**Leak Location:** 0' from A

**Comments:** This is a hydrant leak.

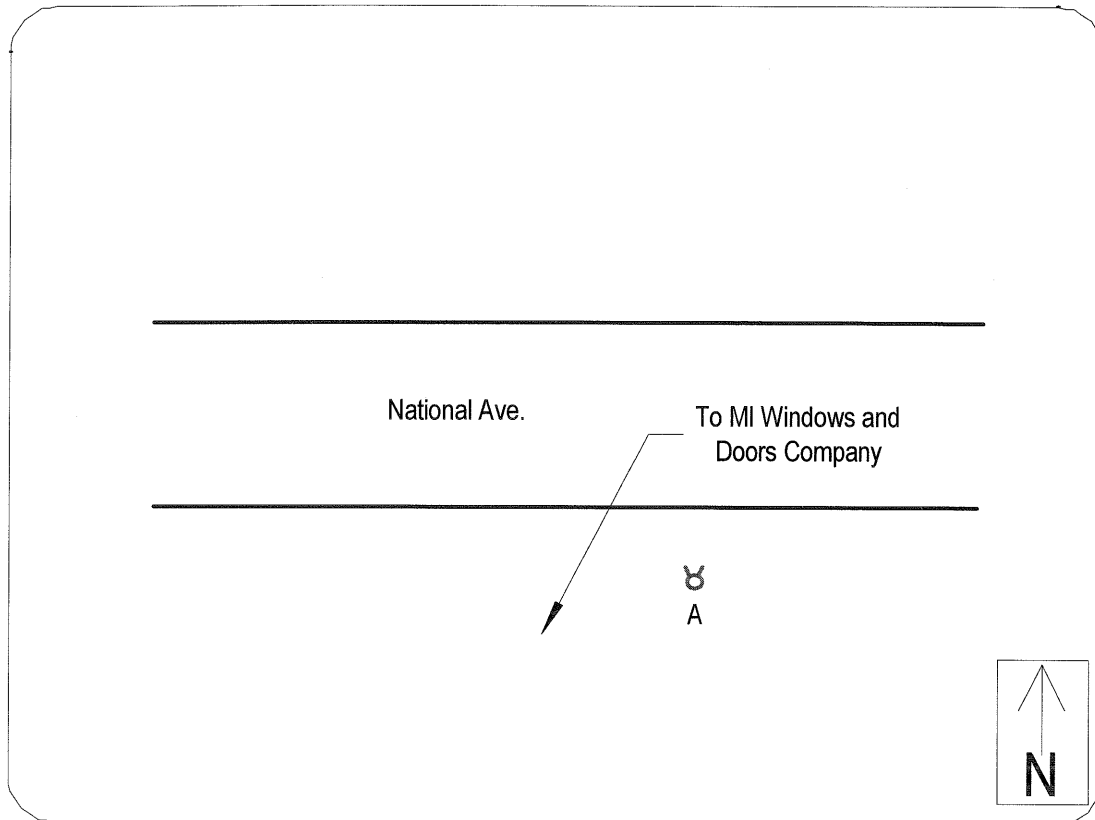
**Address:** National Avenue & MI Windows and Doors Company

**Leak Location:** 0' from A

**Comments:** This was a hydrant leak. We tightened the hydrant top nut and the leak noise quit. This leak is fixed.

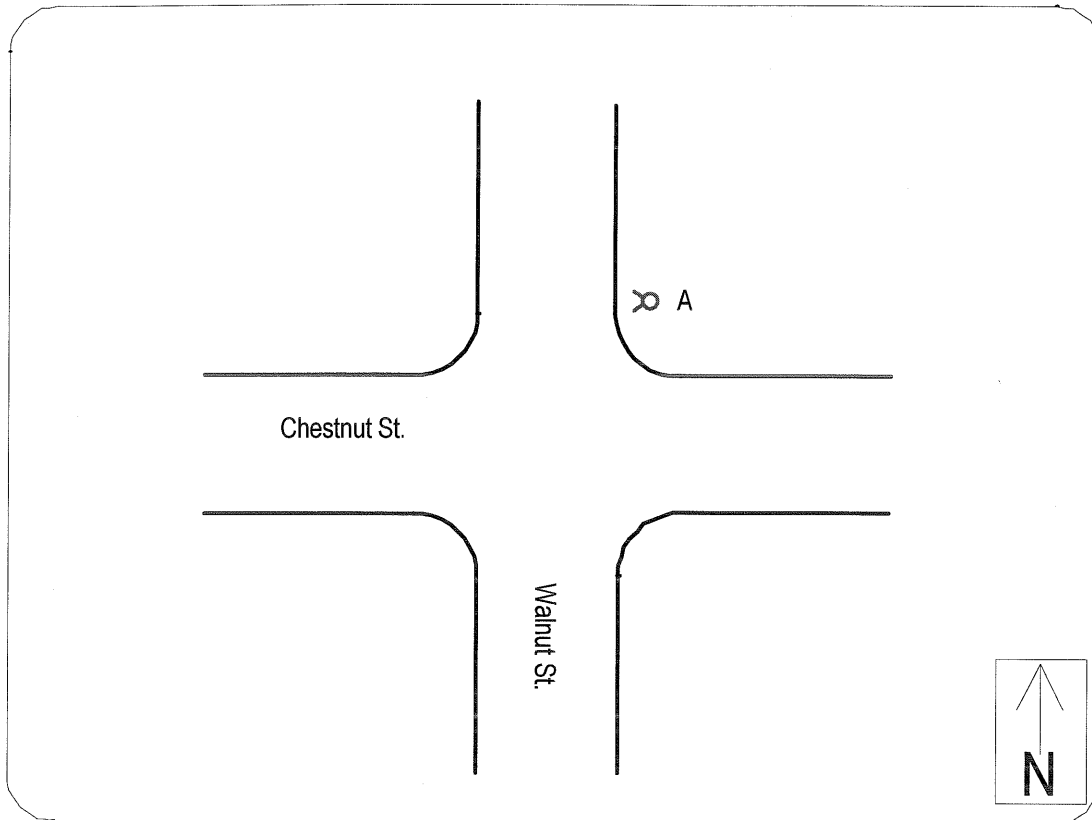
**Address:** Walnut Street & Chestnut Street

**Leak Location:** 0' from A

**Comments:** This is a hydrant leak.

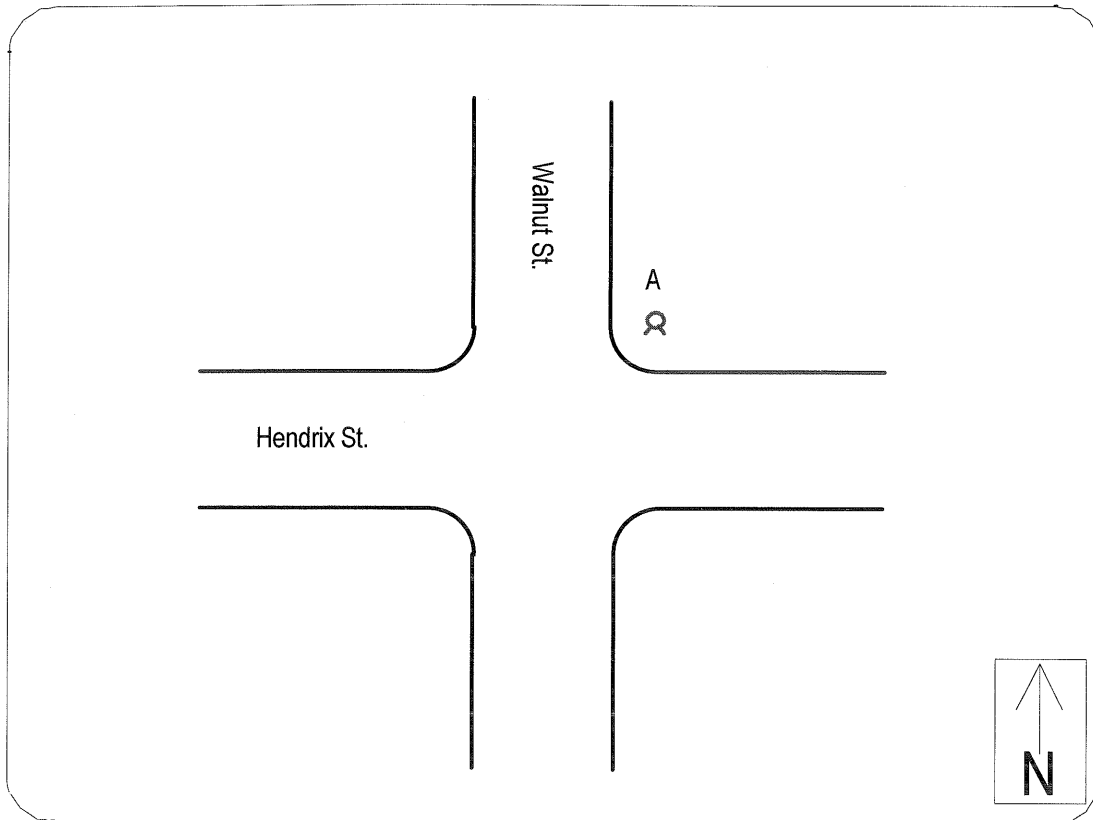
**Address:** Walnut Street & Hendrix Street

**Leak Location:** 0' from A

**Comments:** This is a hydrant leak.

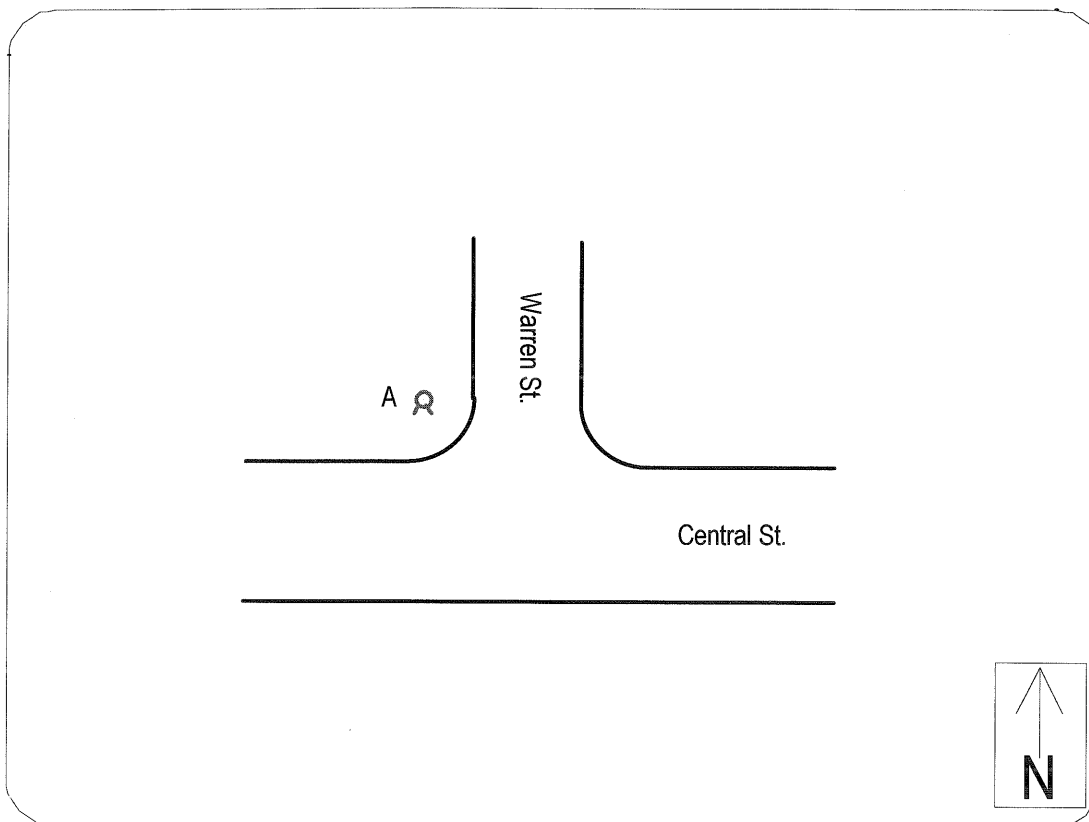
**Address:** Warren Street & Central Street

**Leak Location:** 0' from A

**Comments:** This is a hydrant leak.

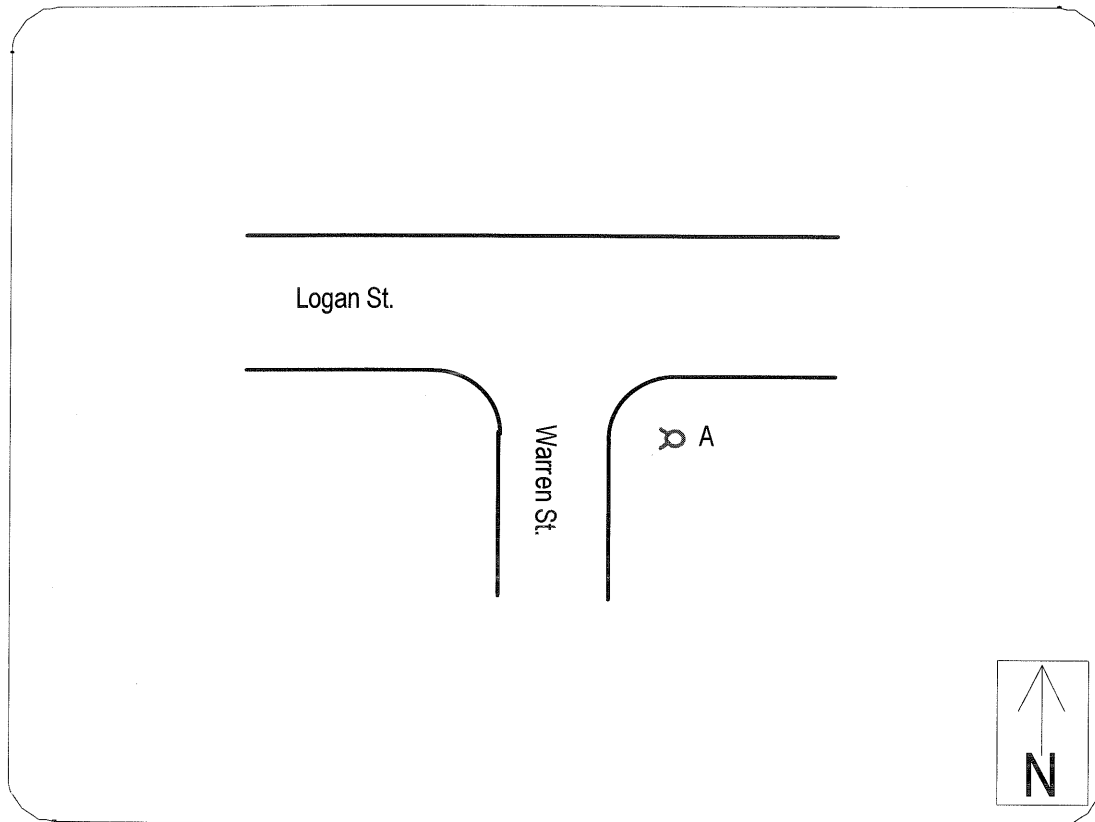
**Address:** Warren Street & Logan Street

**Leak Location:** 0' from A

**Comments:** This is a hydrant leak.
